# Glitched on Earth by Humans: A Black-Box Security Evaluation of the SpaceX Starlink User Terminal

Lennert Wouters

COSIC

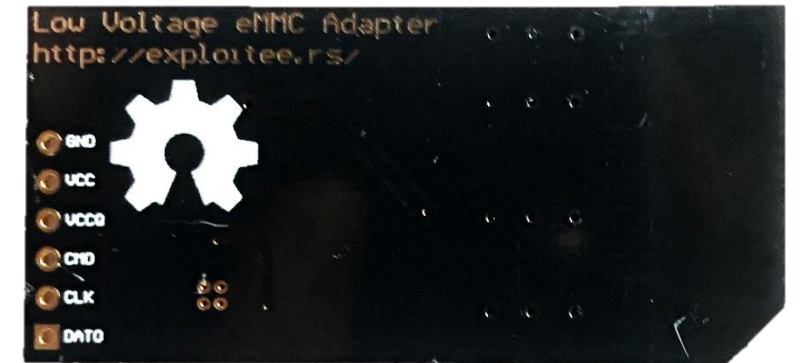
# Reading eMMC in-circuit

SD card reader

← What I did

TXS0202EVM  
Level shifter

What I recommend →

Low Voltage eMMC Adapter  
by  
**e~~x~~ploitee.rs**

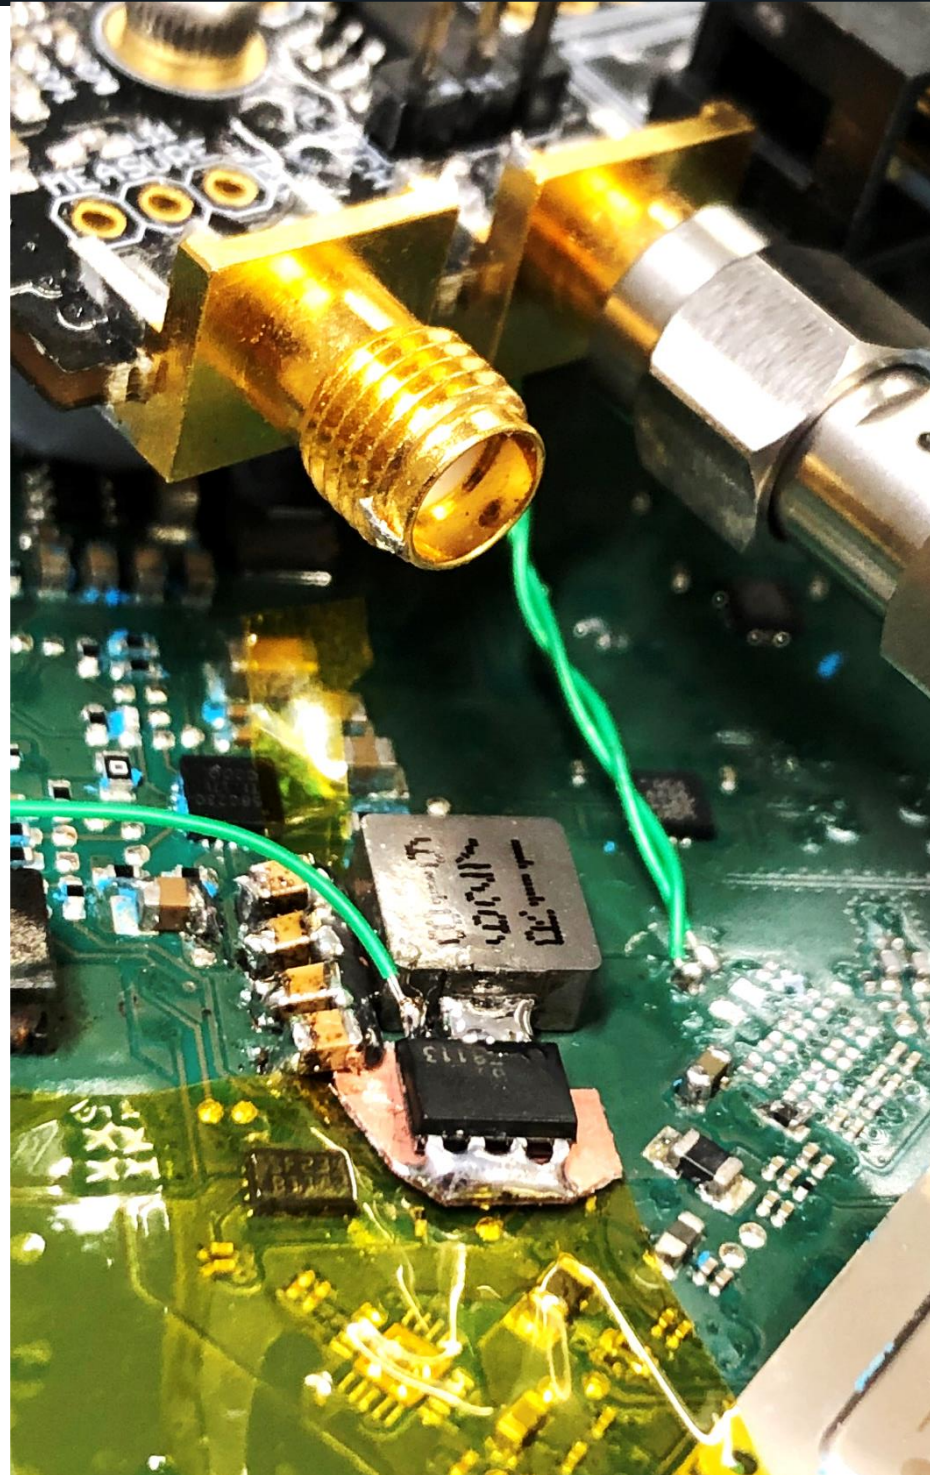
- Decoupling capacitors are needed for later boot stages
- Experimented with:
  - N-channel MOSFETS
  - P-channel MOSFETS
  - High/Low side switching
  - Gate voltage
  - MOSFET drivers
  - Capacitor sizes
  - Timing

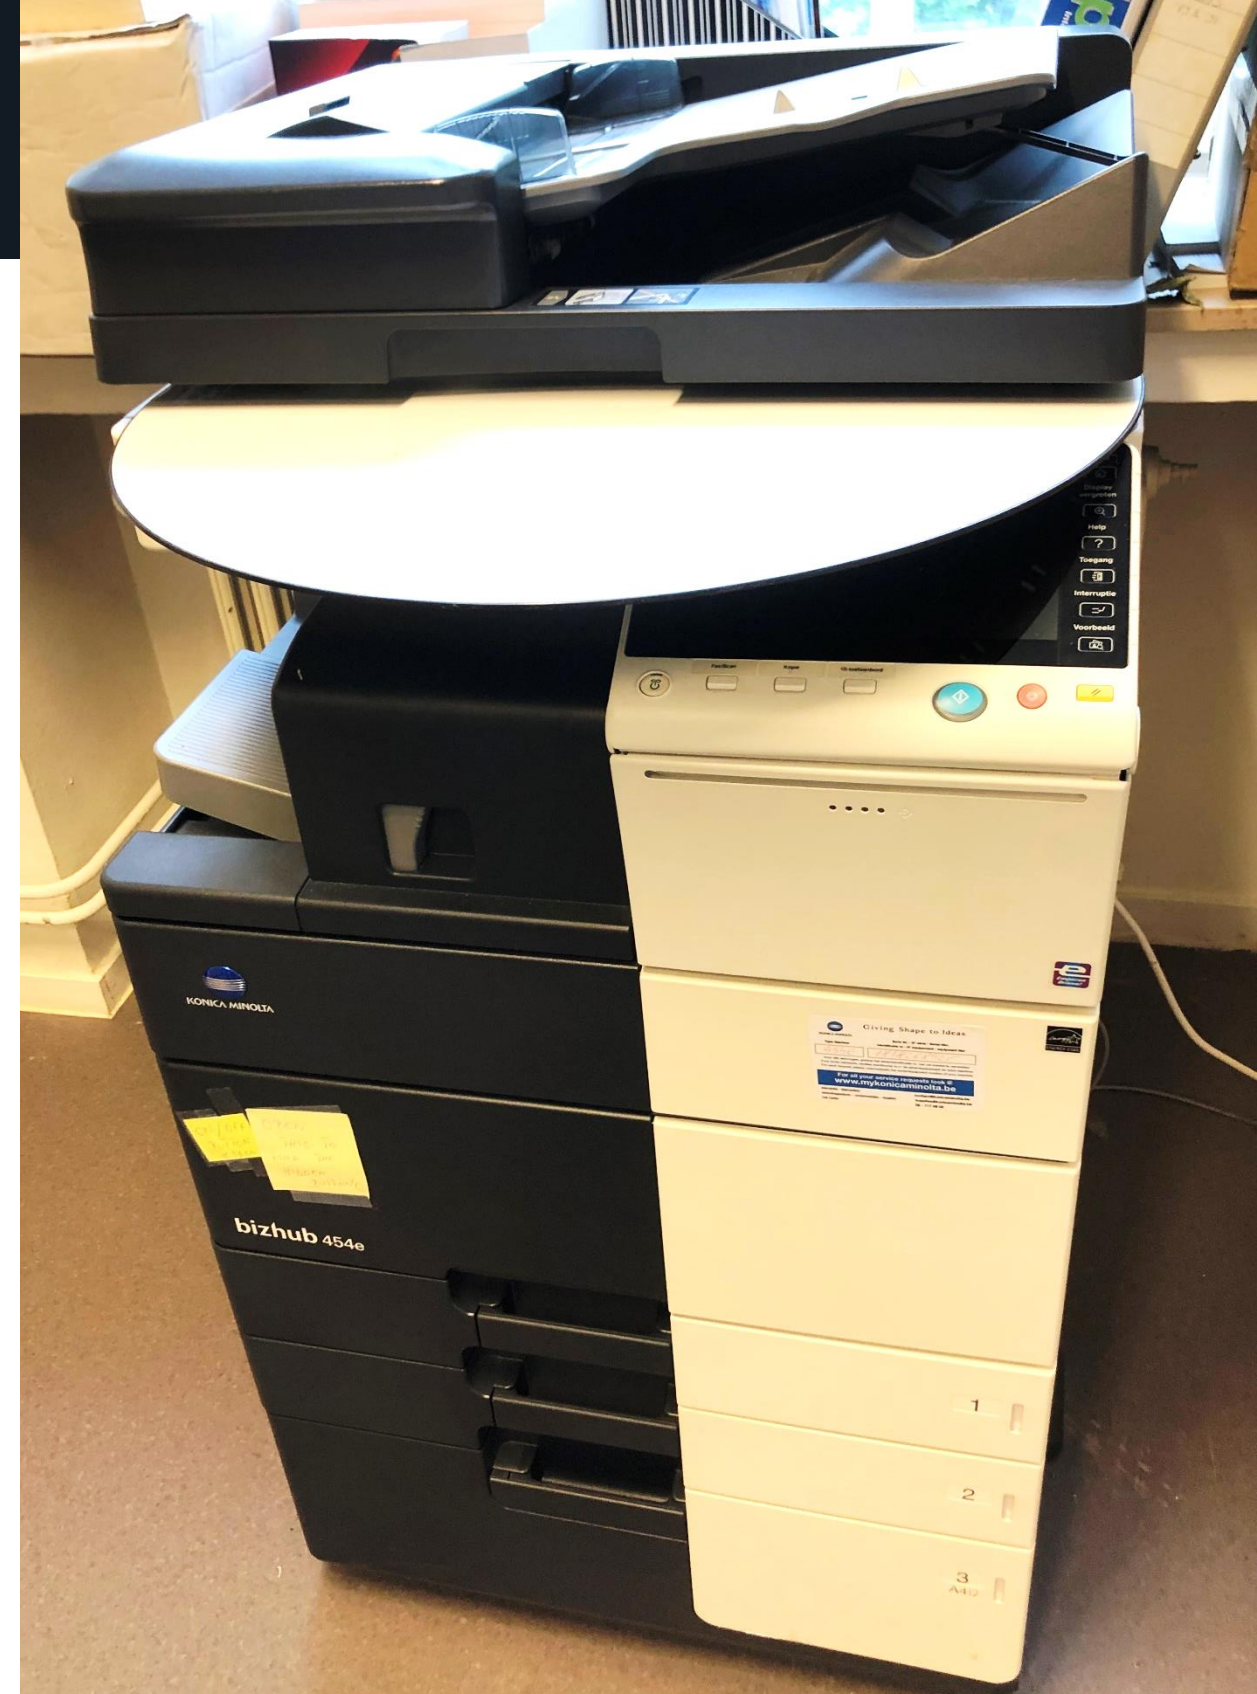
# PCB design

- Scanner @ 600 DPI
- Draw board outline at real size in Inkscape
  - Load in KiCad and use in the edgecuts layer
